**STS-108
FLIGHT READINESS REVIEW**

NOVEMBER 15, 2001

Orbiter

AGENDA

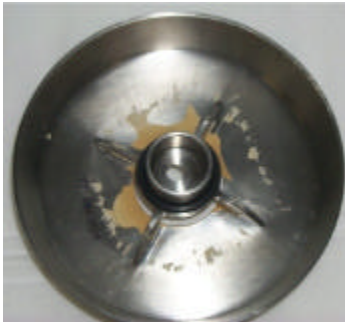
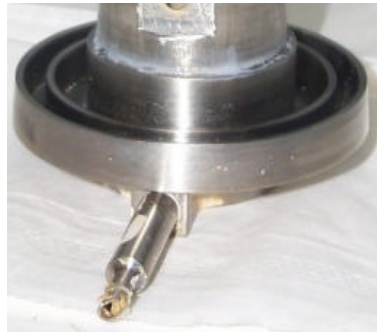
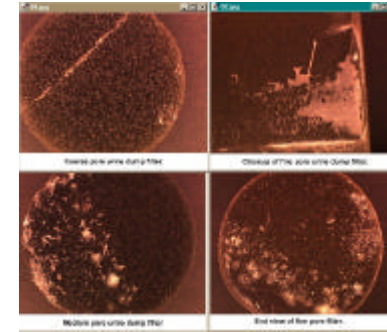
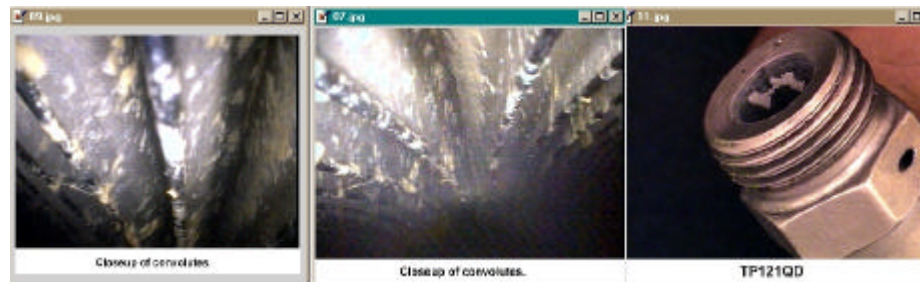
- After STS-97/4A, “Uric acid” deposits found in WCS and Waste Water Management System (WWMS)
 - Significant blockage found in WCS fan separator pitot tube
 - Deposits found in waste tank and high-capacity dump filter

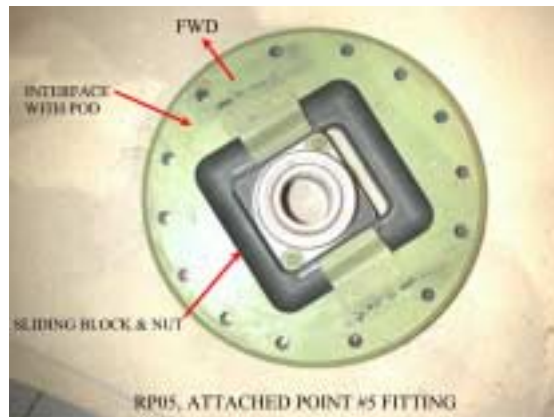
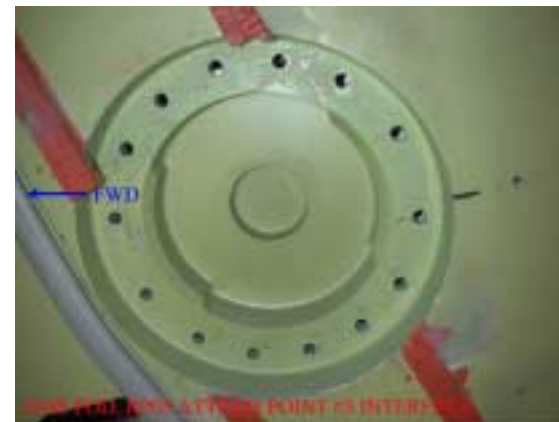
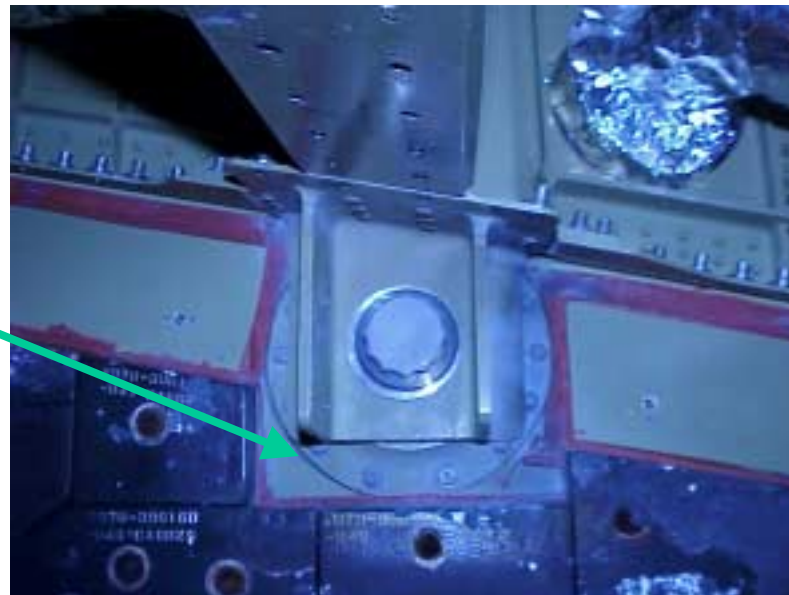
- Holes in the attach point 5 “puck” assembly on OMS pods LP05 and RP05 were found discrepant and elongated
 - Worst case hole elongation found on LP05 or RP05 was 0.030

Gap area between
puck & boss

- Tests show that reasonable assumption of 0.030 hole elongation (LP05 and RP05 three-sigma condition) on LP04 and RP01 (OV-105) can be tolerated with significant conservatism
- Tests show that largest measured gap between puck and boss can be tolerated without failure

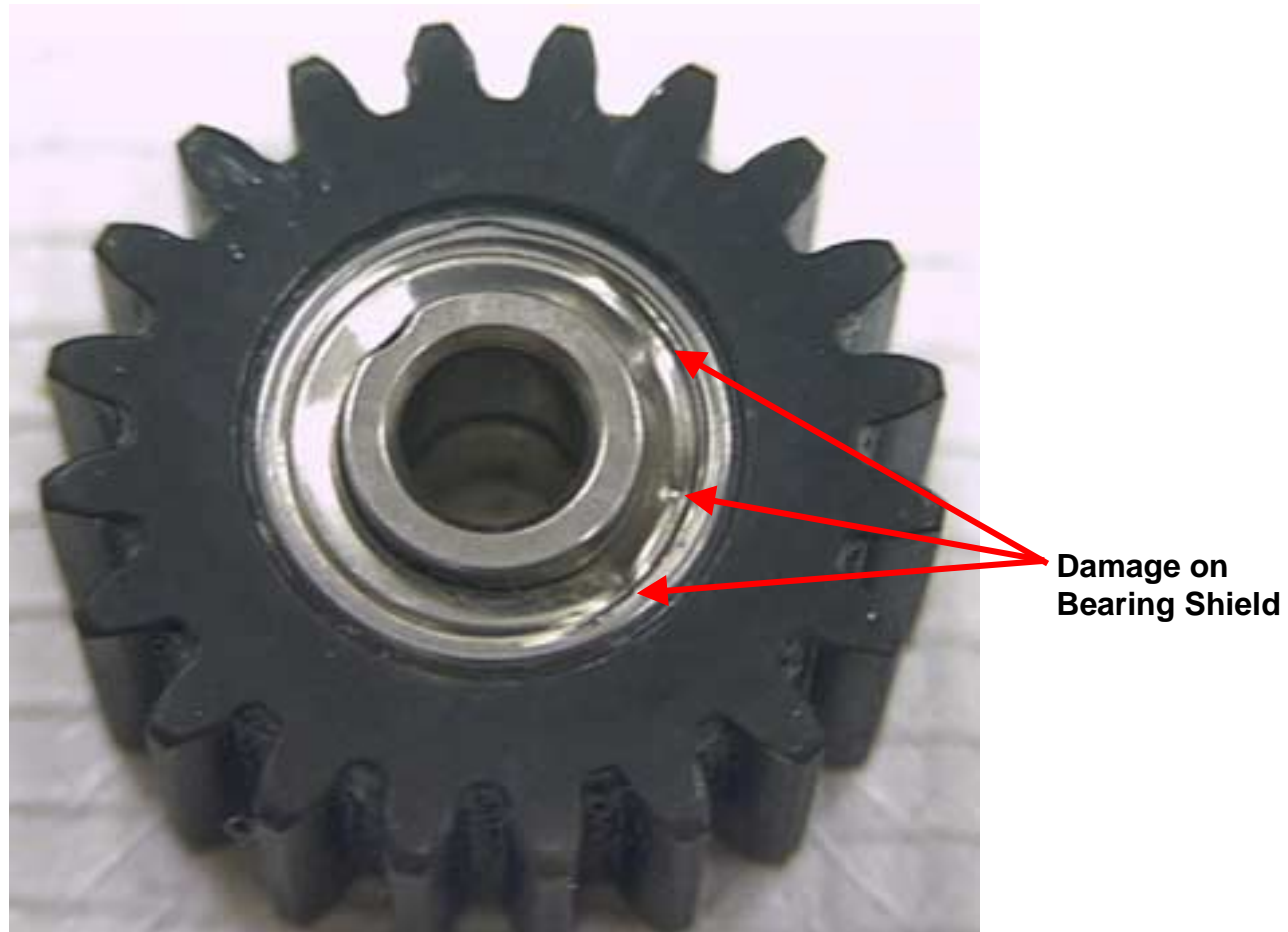
- Actuator subjected to and passed ATP
- During dielectric strength test, voltage inadvertently set to over double required level
 - Required replacement of both motors again and three switches
- During second motor replacement, technician noticed one of two gearbox input pinion gears was difficult to rotate by hand
- Gearbox was disassembled to determine cause of binding
- Several observations made upon disassembly:
 - Additional binding found in output shaft planetary gearset (Fig 2)
 - Bearing holes in input pinion gear housing measured and found to be slightly undersized (Fig 2)
 - Possible cause of binding since bearing could not be completely seated
 - One output shaft planet gear had damage on bearing shield (Fig 3)
 - Two loose bearing shields found stuck to the gearbox wall
 - One differential bearing missing shield (Figs 4)

Figure 3: Output Shaft Planet Gear with Damaged Bearing Shield

- PRT concluded improper assembly was the most likely cause of loose shields
 - Two shields could have been installed on one side of bearing
 - Demonstrated at NSLD
 - As a result of extra thickness, retainer wire not seated properly
 - Shields dislodged when differential rotated at operating speed
 - Multiple assembly problems in same unit
- Six other Ellanef actuator gearboxes have been opened at NSLD in the past with no FOD found
 - 4 Vent Door, 2 Star Tracker Door
- All Ellanef actuators on OV-105 have been installed since first flight (16 flights total)
- Review of GIDEP failure history and discussions with bearing manufacturer indicate no prior history of this type of bearing problem

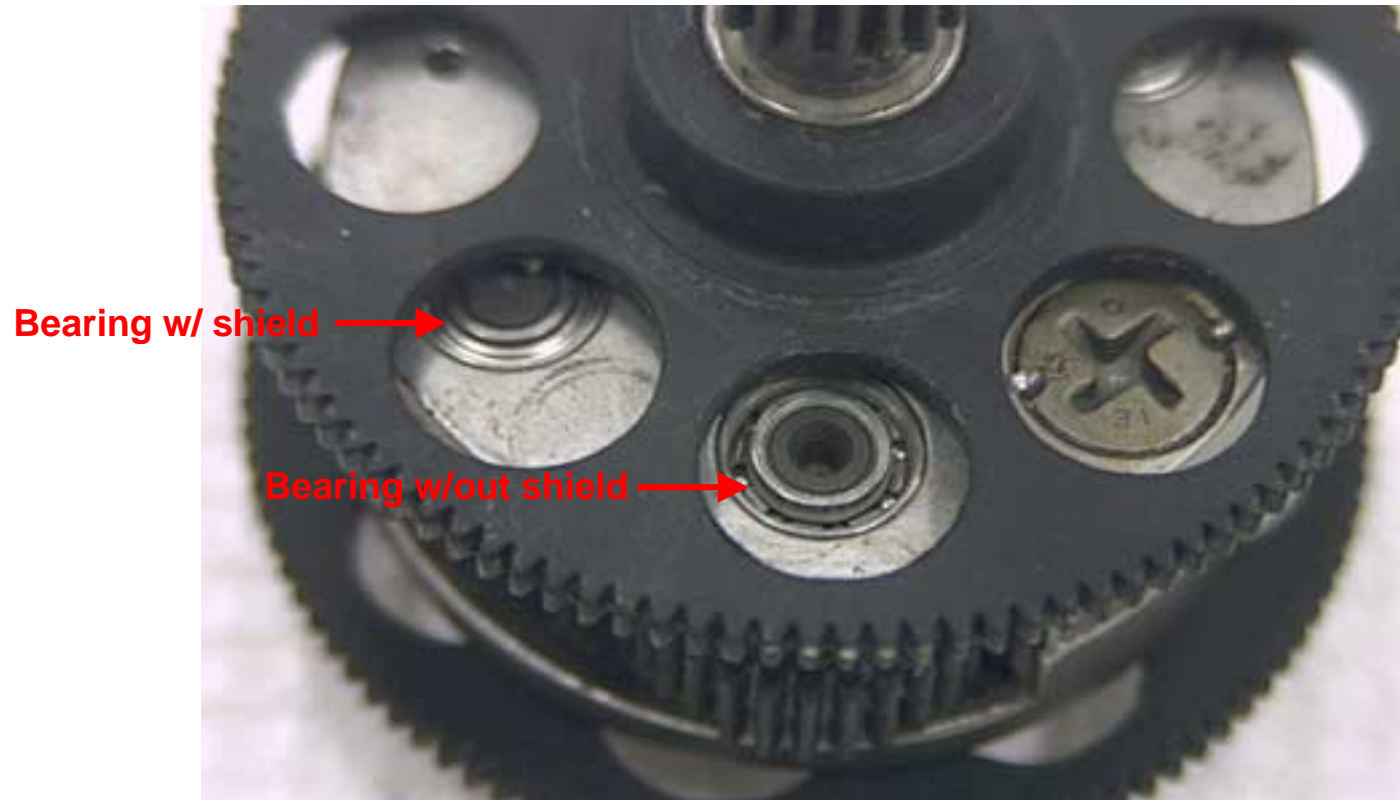
Figure 4: Differential Bearing Missing Shield

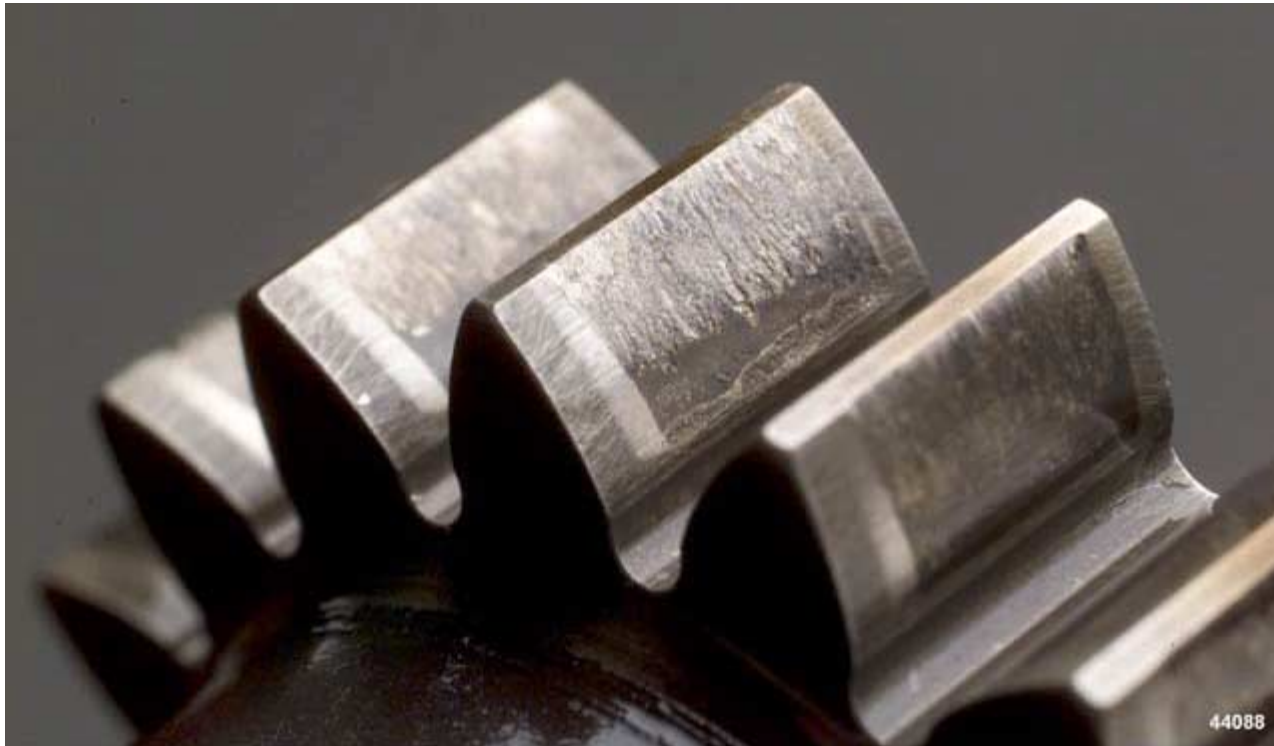
- Scuffing observed on gears 5 and 6, on only one side of the gear teeth, in the tooth-tooth contact area
 - See illustrations on following pages
 - Corresponds to Speedbrake close direction

Scuffing on input gear, P/N 5001517, S/N D5G014, on one side of gear teeth. Polishing over the scuffing edges indicates that the gear most likely operated in this condition for some time. This gear connects with the Speedbrake System 2 hydraulic motor directly through a series of splined shafts. During normal operation, it drives p/n 5001513 ring gear (next page) either clockwise or counter clockwise.

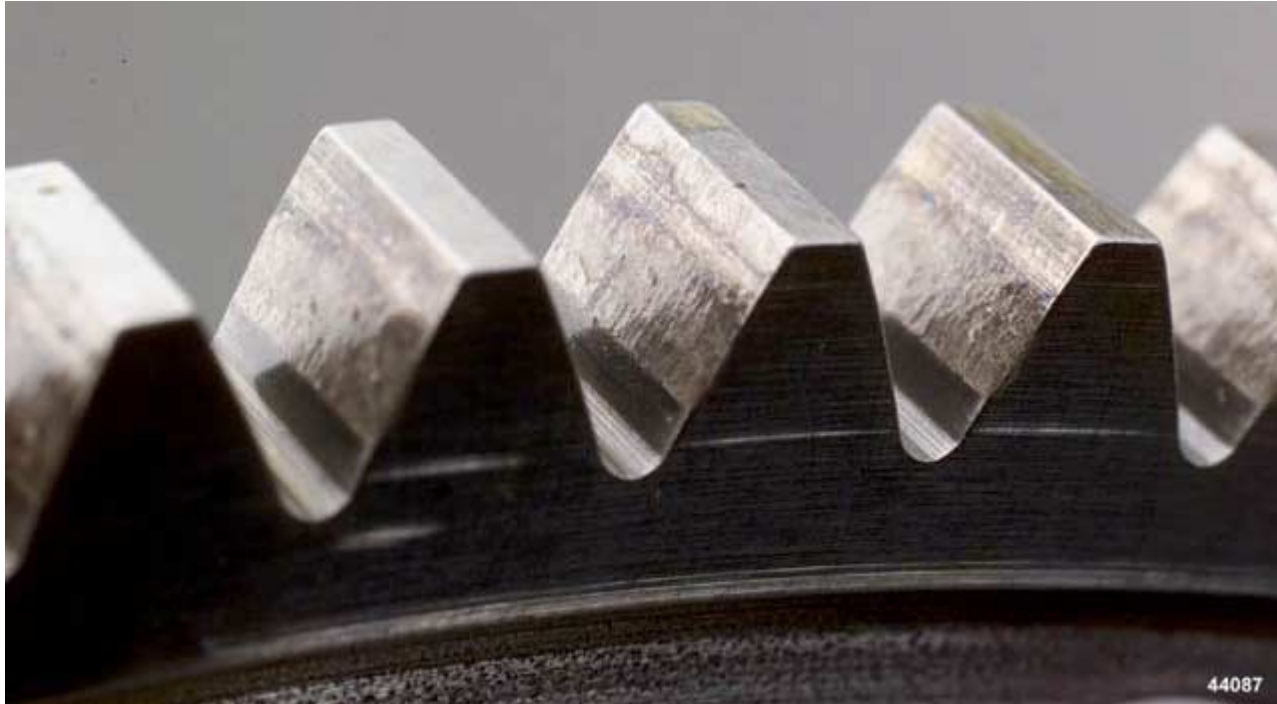
Scuffing on ring gear, P/N 5001513, S/N D5K012, on one side of gear teeth.
During normal operation, it is driven by the input gear (previous page).

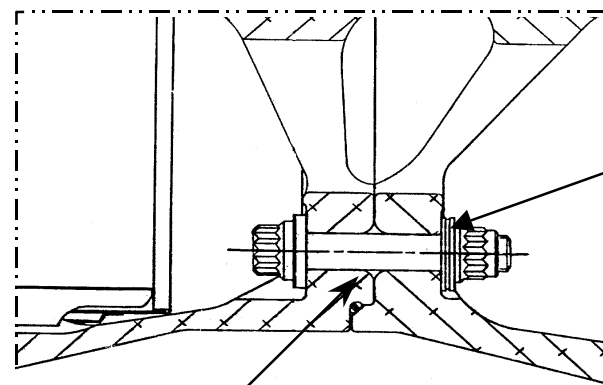
Nut spot face
with corrosion pits

Radius Location with
corrosion pits

- During the scheduled 10 flight refurbishment of MLG wheels at Goodrich, visual inspection revealed signs of corrosion pits in tie-bolt hole areas
 - Corrosion on the edge radius of holes, washer bearing surfaces, and inside some holes (areas with chem film and primer only, no white top coat)
 - No cracks were discovered during NDI inspection (dye-penetrant)
- To increase the sample size, an additional set of 7 wheels were sent to Goodrich for inspection
 - Visual appearance of the corrosion was similar to the first group of wheels
- To further increase the sample size, OV-103 wheels were sent to Goodrich, bringing the total to 17
 - Visual appearance of the corrosion was similar to the first group of wheels

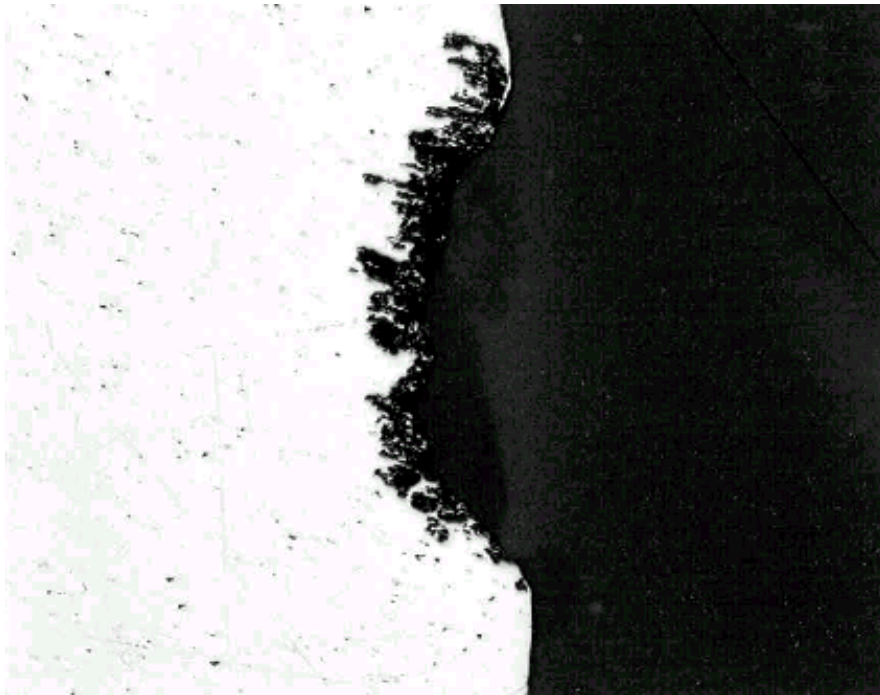
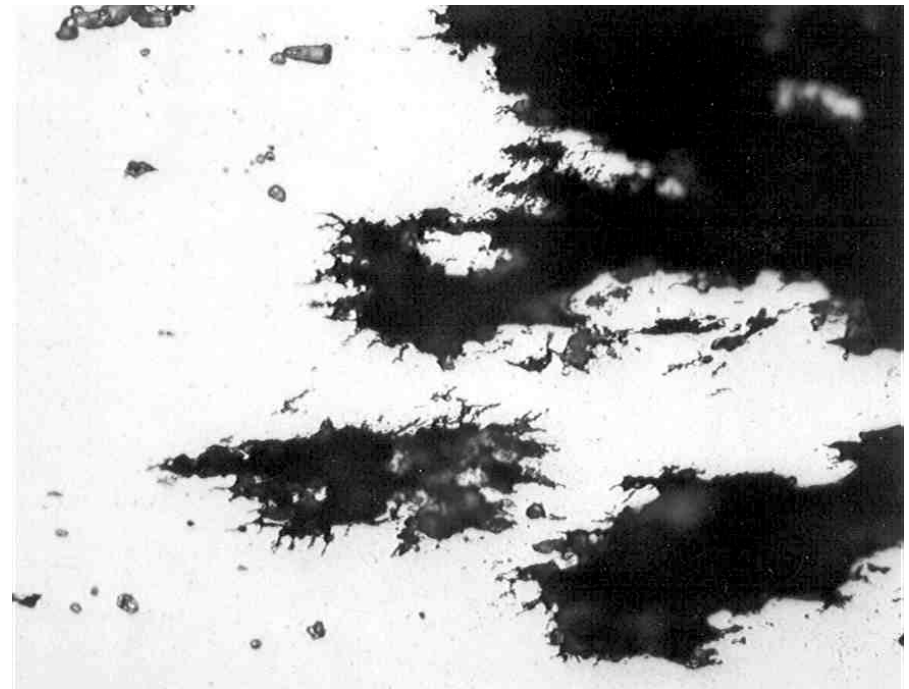
Corrosion Cross Section

- Of the 30 wheels in the fleet, 17 have been inspected at Goodrich and 35 corrosion pits on 4 wheels have been machined to measure total depth
 - 2 of these wheels (S/N's 029 & 30M) were given priority because the corrosion visually appeared to be worst, the other 2 (S/N's 75M & 42) were selected because the severity of the corrosion visually appeared medium - light

- Sampling has corroborated that there is correlation between the visual appearance of the corrosion damage site depth and the actual depth as determined by machining
